# FORDING RIVER HABITAT REHABILITATION NEAR THE CONCRETE ARCH BRIDGE

Robinson, M.D.\*<sup>1</sup>, Gaboury, M<sup>2</sup> and C. Sutherland<sup>3</sup>

Teck Coal retained the services of Lotic Environmental, MN Gaboury, and Kerr Wood Leidal to design the Fording River Habitat Rehabilitation near Concrete Arch Bridge offsetting measure required as part of Teck's Line Creek Phase II mine extension fish habitat offsetting plan. The design team employed a natural channel design process to develop the rehabilitation design. This approach used regional relationships of channel morphology-vs-drainage area and channel metrics from undisturbed reaches as a natural template to identify channel metrics and processes assumed to be outside of what would be expected for a natural site. A design was developed with specific treatments to promote an accelerated recovery of habitat quality over time, allowing the river to repair itself. Channel width-to-depth ratio, percent pools, and woody debris abundance were key aspects targeted for rehabilitation. Rehabilitation treatments were completed in fall 2016 and included 27 instream jams and 103 bar top structures in 1,280 m of channel. Two meander b

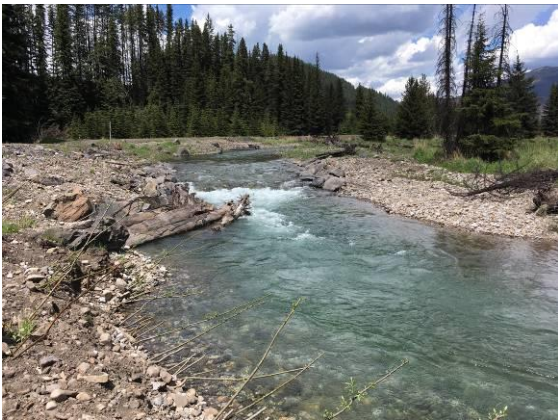
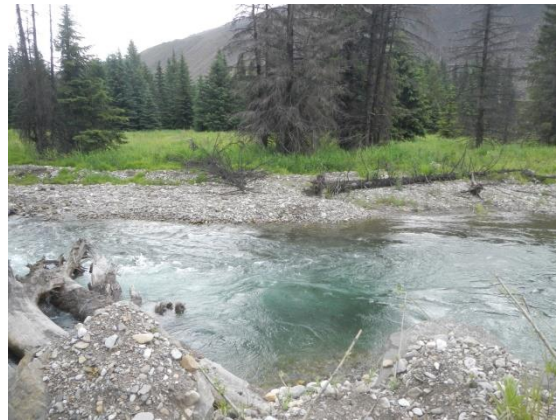
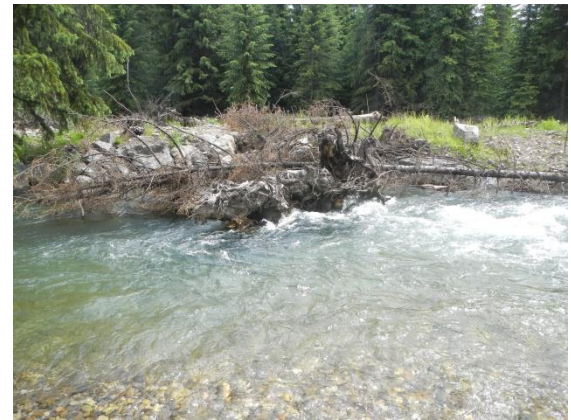
**Figure 2. Plan view of lower half of the rehabilitation reach (top), downstream view of LWD 21 (bottom left), cross-channel view of LWD 21 (bottom middle), and cross-channel view of LWD 25 (bottom right).**

Reach-level channel morphology data were collected to describe current conditions at the rehabilitation site. Comparison between existing site conditions and predicted natural channel characteristics helped to identify channel metrics and processes that were outside of what would be expected for a natural site. Treatment designs were then prepared to accelerate channel recovery to a more natural state. Specific to the Fording River Habitat Rehabilitation near Concrete Arch Bridge, channel width-to-depth ratio, percent pools, and amount of LWD present were identified as key aspects targeted for rehabilitation. Rehabilitation treatments were constructed in fall 2016 and included 27 instream LWD structures and 103 bar top structures in 1,280 m of channel (Figure 2). Two natural meander bends were also rehabilitated, each with riffle structures constructed to provide bed stability. Bioengineering (i.e., live staking, rooted cuttings, and brush layers) was completed in spring 2019 to promote riparian vegetation re-establishment.

Cross-sectional and longitudinal profiles provided an effective qualitative and quantitative assessment of changes in channel morphology. Cross-sectional profiles were surveyed at six permanent transects (Cross Section XS 13-18) (Figure 2). Cross Section XS13 was located on the lower portion of the treatment reach and through the apex of a LWD structure to monitor location of where a pool would likely form. It was shown that the thalweg had deepened approximately 0.30 m. As well, the cross-sectional profile had formed a more typical shape of what would be expected along the outside of a meander (Figure 3). This location was a relatively deep glide in 2016 meaning that extensive pool development would not have been expected from pre-construction conditions. Cross Section XS 16 was located downstream of a LWD structure. This section was through a riffle at the time of construction and the bed scour of 0.4-0.5 m is more indicative of how much scour can occur at a LWD structure (Figure 4).

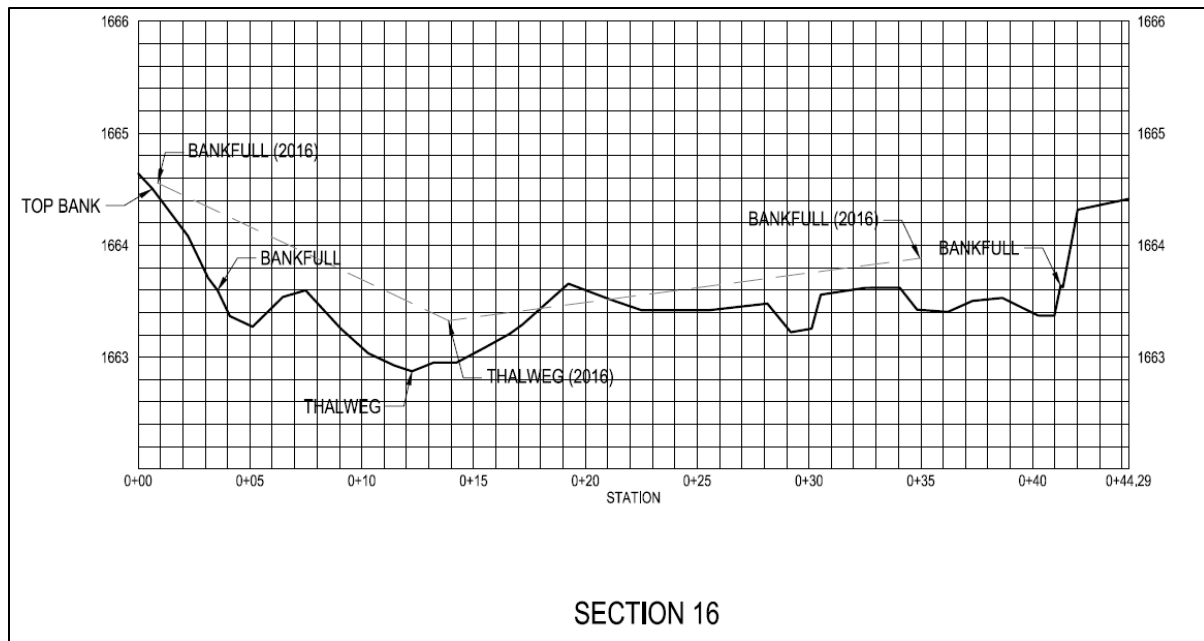
**Figure 4. Cross-sectional profile at Cross Section XS16.**

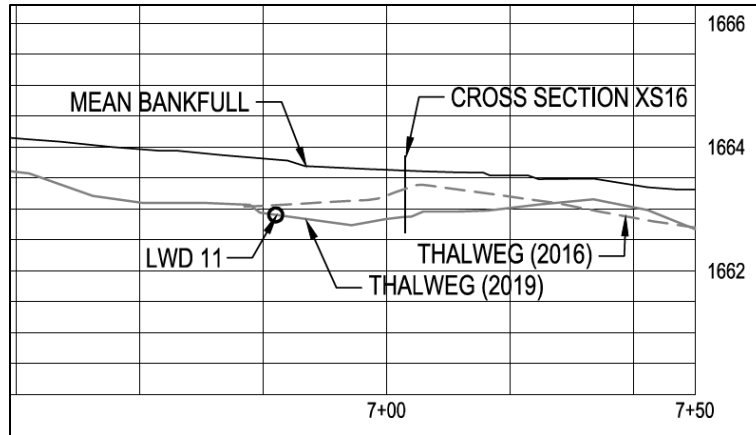
**Figure 5. Longitudinal profile plot of the 2016 and 2019 thalweg in association with LWD 11.**

The final assessment of changes in habitat came from a qualitative assessment of the longitudinal profile. A longitudinal profile was used to plot the thalweg from 2016 and 2019, as well as the mean bankfull elevation from 2019. Assessment of changes in thalweg elevation around LWD structures further corroborated the data provided from the topographic surveys, FHAP assessments, and review of the cross-sectional profiles. In all instances, the data suggest that the rehabilitation prescription was successfully increasing the abundance of pool habitat and increasing the amount of functional LWD. However, the previous data did not demonstrate the connection of the two improvements as well as the longitudinal profile did. Two examples of the relationship between LWD and pool scour depths are provided below with LWD 11 and LWD 21. The plot of LWD 11 shows the flow of the Fording River from left to right (Figure 5). This plot shows how the thalweg has dropped in elevation from 2016 to 2019 and clearly demonstrates how this was associated with the hydraulic scour induced by LWD structure 11. Also apparent in the plot is XS 16, which was discussed above. The most drastic change in thalweg profile from 2016 to 2019 observed over the entire Fording River Habitat Rehabilitation near Concrete Arch Bridge was associated with LWD 21. Here the scour created by the LWD structure effectively created approximately 1.5 m of scour over the three year period (Figure 6). The traditional scour pool followed by a downstream tailout can be clearly seen in the profile plot.
